INVENTORY OF MONUMENTS AT PAGAN

Volume One
Monuments 1-255

PIERRE PICHARD

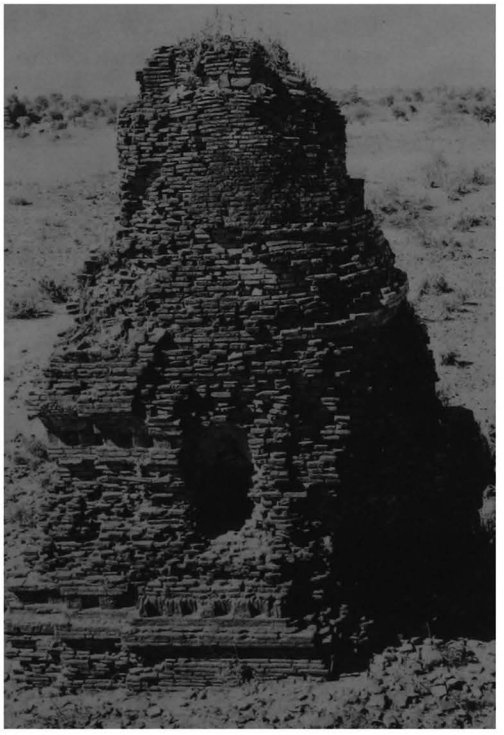
5 present condition
- half-ruined.
- upper parts badly damaged.

968 b - From east

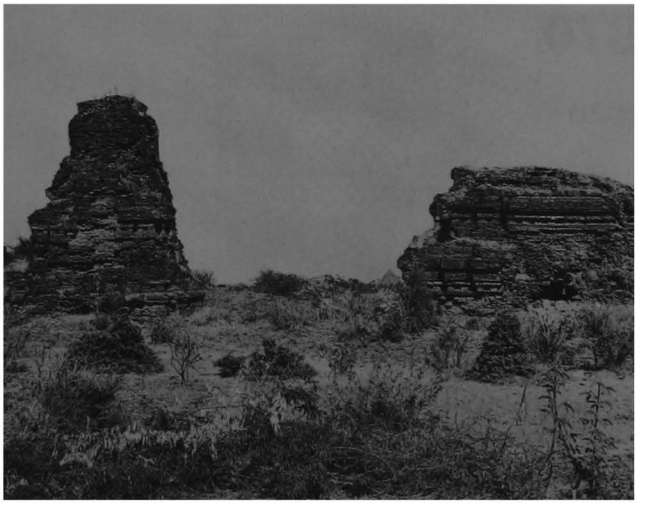
968 c - From south, together with 969

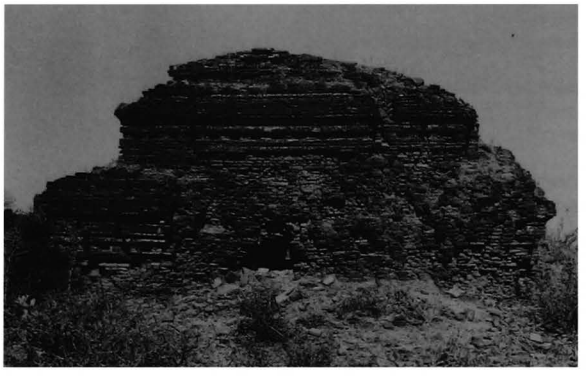
969 b - South face

5 present condition
- ruined.
- base and terraces disintegrated.
- upper parts destroyed.

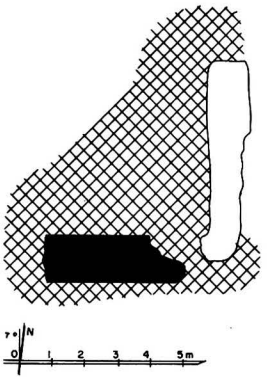
973 a - Plan

5 present condition
- ruined.
- only south-east corner remains.
- ground floor buried under debris.

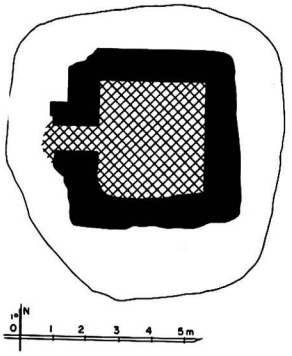
974 a - Plan

5 present condition
- ruined.
- vaults and upper parts collapsed.
- ground floor buried under debris.

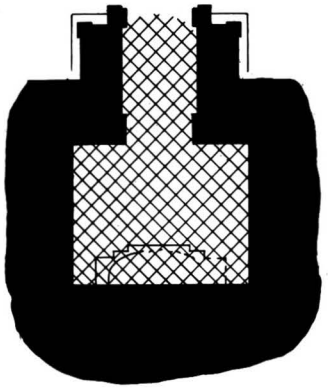
975 a - Plan

5 present condition
- ruined.
- only base of porch remains.
- ground floor buried under debris.

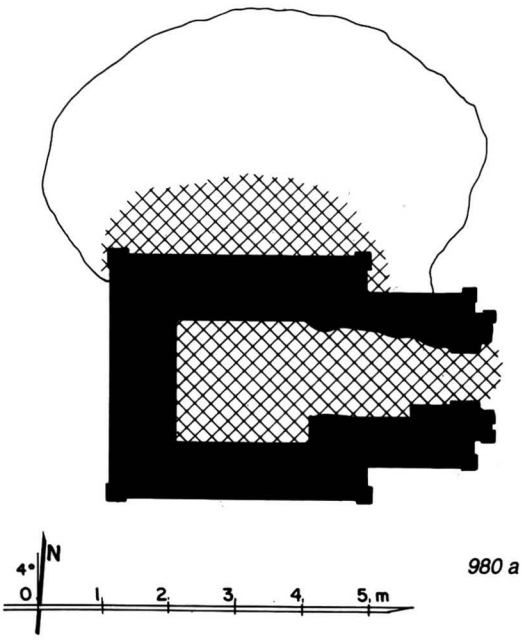
980 a - Plan

5 present condition
- ruined.
- walls, vaults and upper parts collapsed.
- ground floor buried under debris.

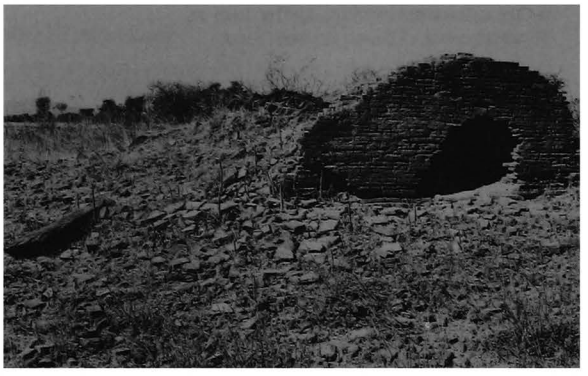
981 b - From north-west

5 present condition
- ruined.
- walls and vault collapsed.
- ground floor buried under debris, approx. height 2.00 m.

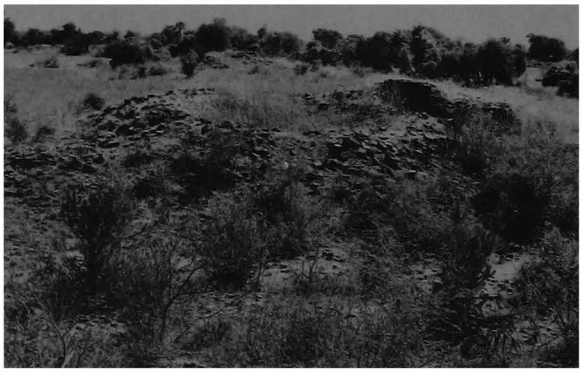
982 b - East face

5 present condition
- ruined.
- walls and vault collapsed.
- only south part of east wall remains.
- ground floor buried under debris, approx. height 1.60 m.

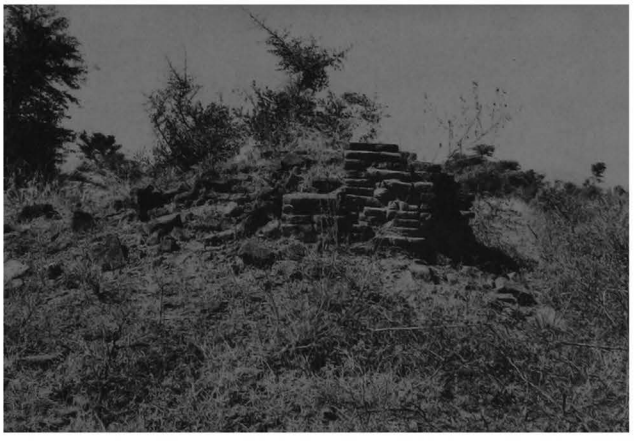
984 b - From east

5 present condition
- north-east corner of a ruined structure (?).
- height: approx. 1.80 m.

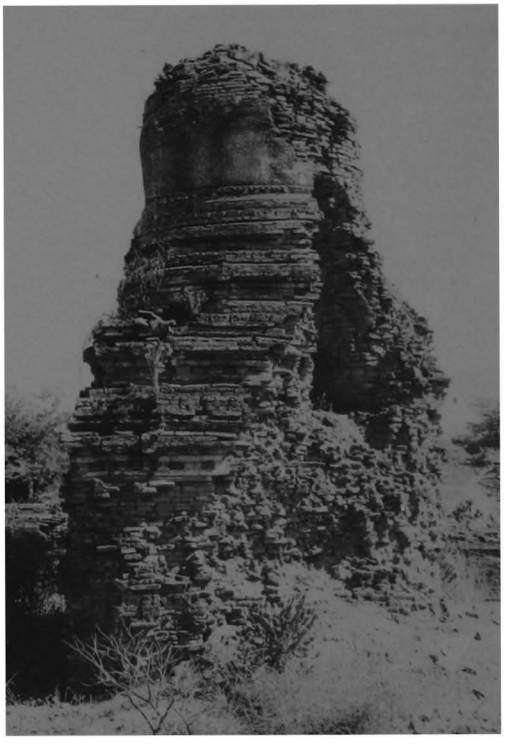
989 c - From west

5 present condition
- half-ruined.
- base and terraces disintegrated.
- upper parts badly damaged.

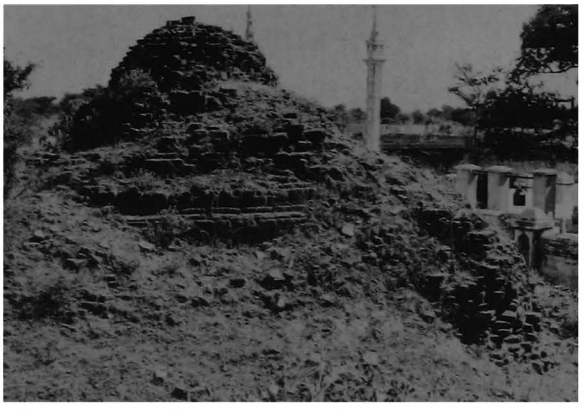
990 b - From north-west

5 present condition
- ruined.
- base and terraces disintegrated.
- upper parts badly damaged.

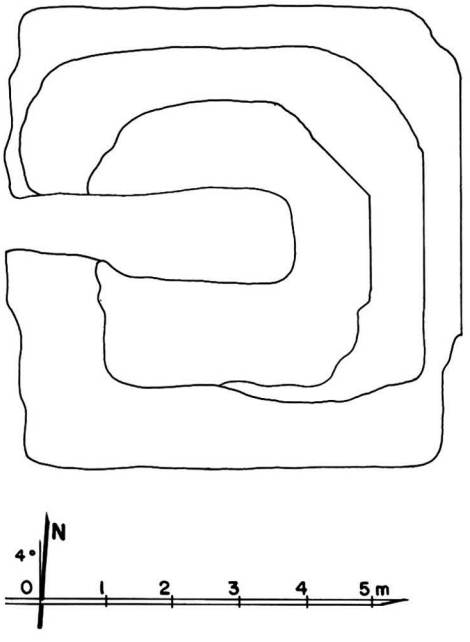
102 c - Shrine vault, from north

coordinates
N : 50.550 E : 11.635

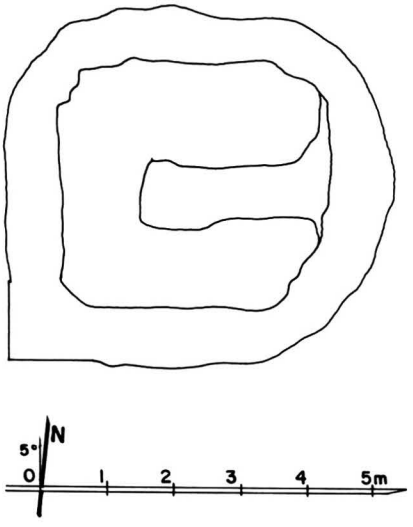
10 construction period
- estimated : **18th century AD.**

105 b - From west

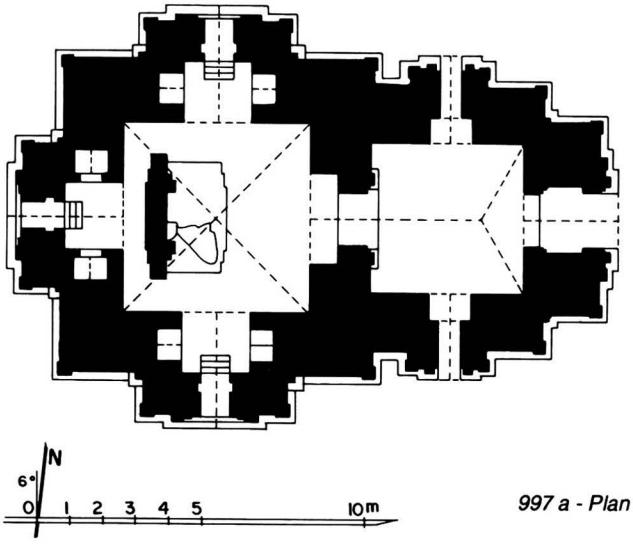
(88) ရွှေတံဆိပ်ဘုရား

3 upper parts
- 1 square terrace with corner peacocks.
- square pedestal.
- circular bellshaped dome and conical spire.

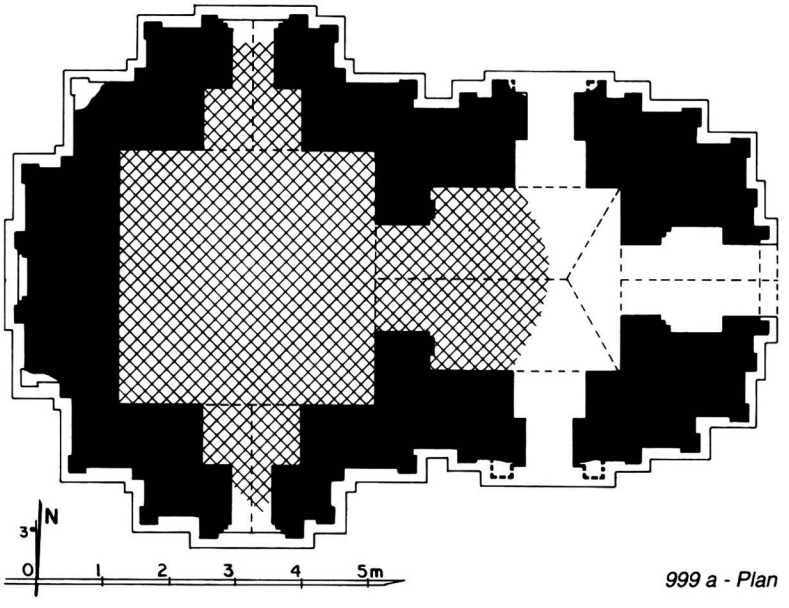
7 decoration
- stucco mouldings, still in place : 95 %.

NYAUNG U (eastern sector)
in the compound
of Myit-kyi monastery

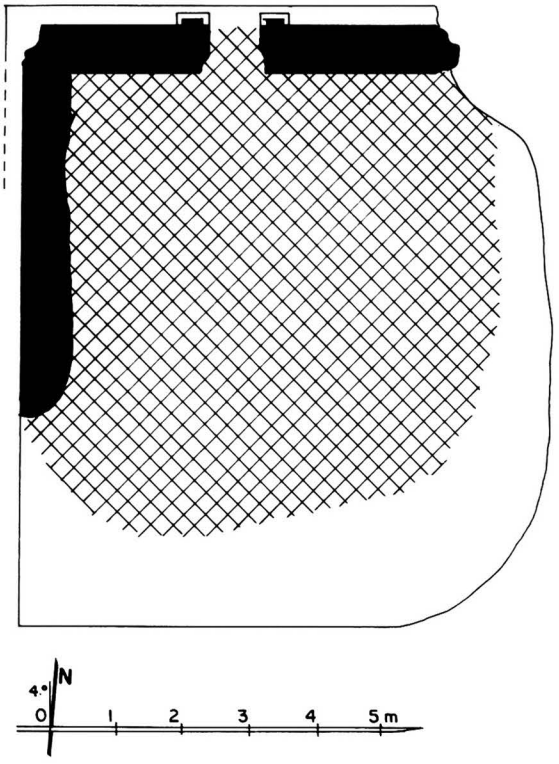
NYAUNG U (eastern sector)
in the compound
of Myit-kyi monastery

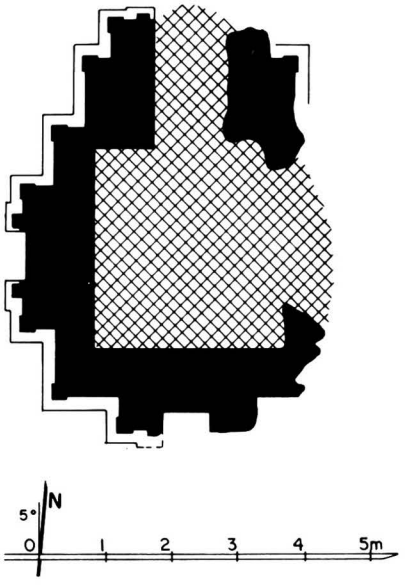
10 construction period
- estimated : **19th century AD.**

NYAUNG U (eastern sector)
south-west of **121 Hsutaung-pyi**

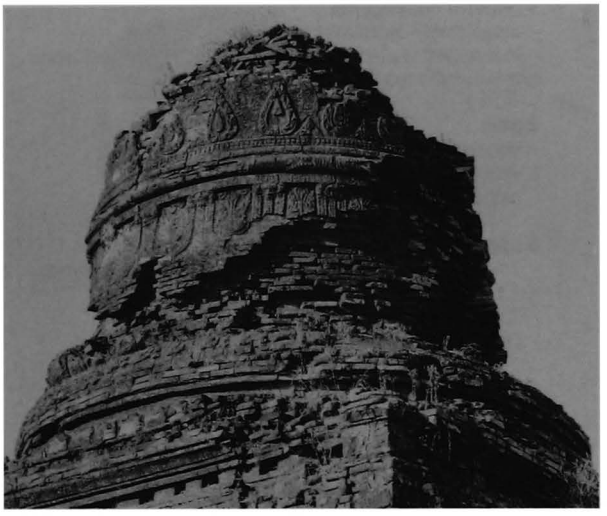
1005 e - Upper parts, from north-east

5 present condition
- no maintenance.
- base disintegrated.
- upper parts damaged.

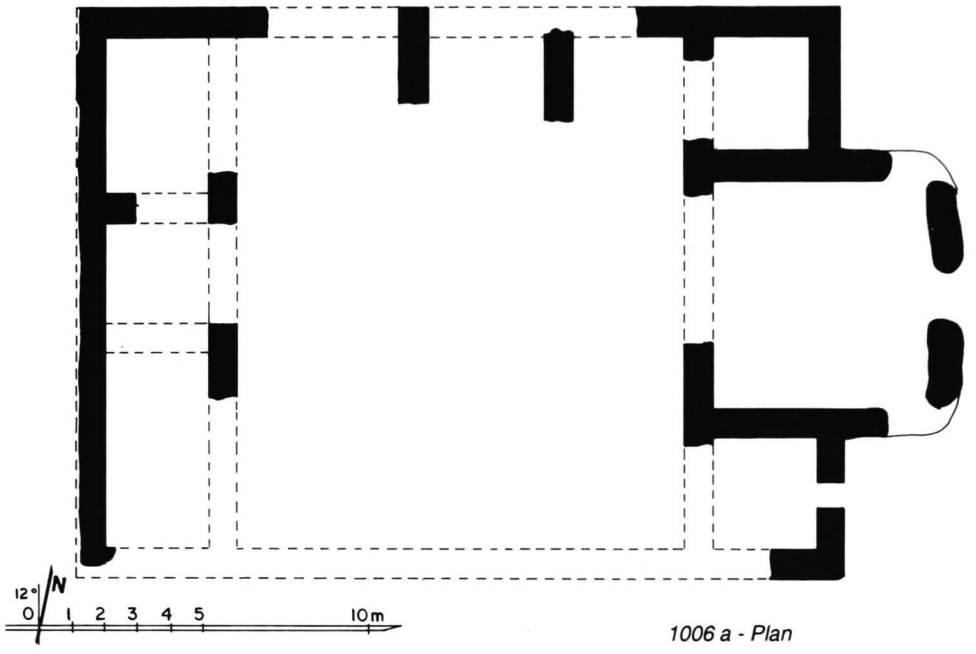
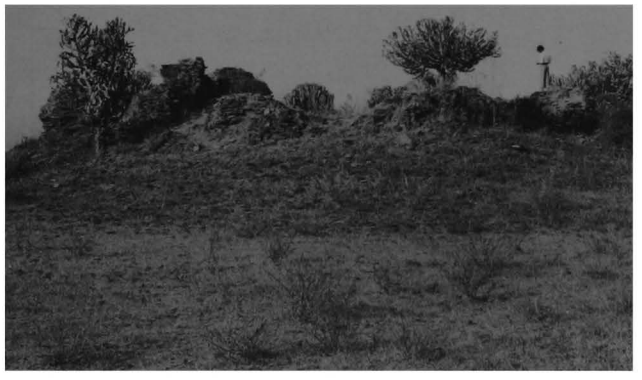
1006 a - Plan

1006 b - From east

1006 c - West face

5 present condition
- ruined.
- no more trace of vaults or roof.
- ground floor buried under debris.

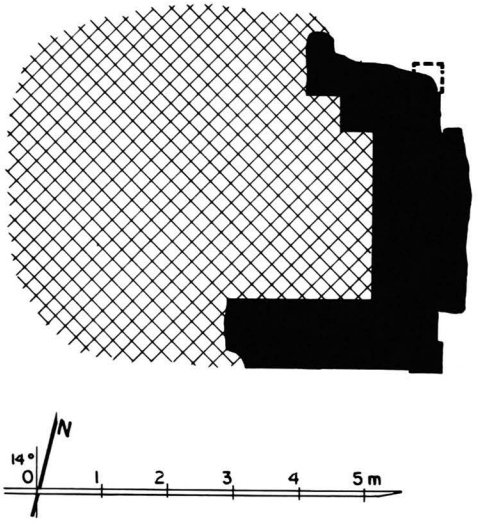
1007 a - Plan

5 present condition
- ruined.
- vaults and upper parts collapsed.
- ground floor buried under debris.

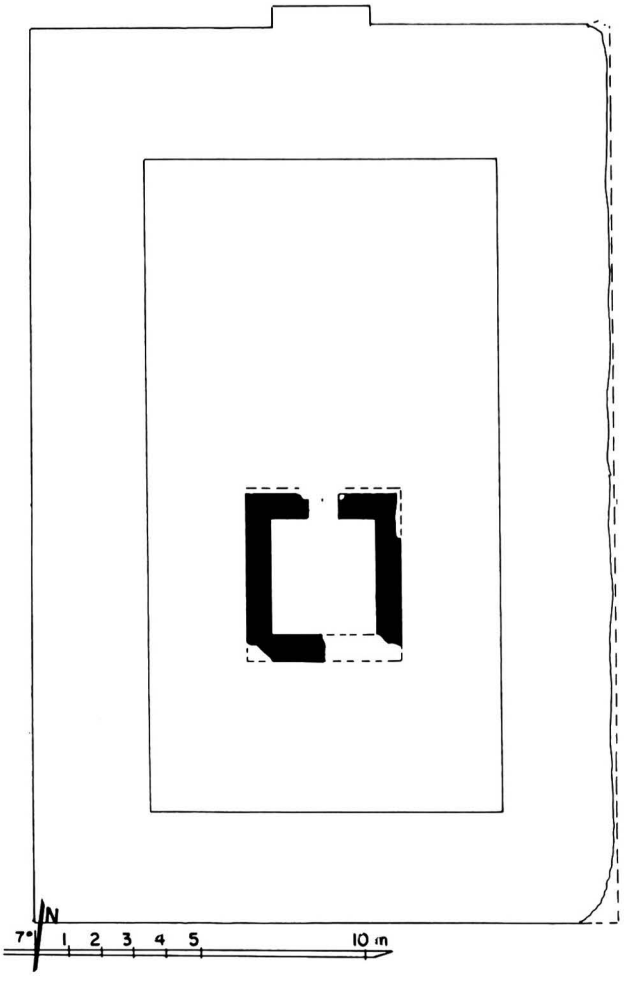
1008 a - Plan

5 present condition
- ruined.
- only base of walls remains.
- ground floor buried under debris.

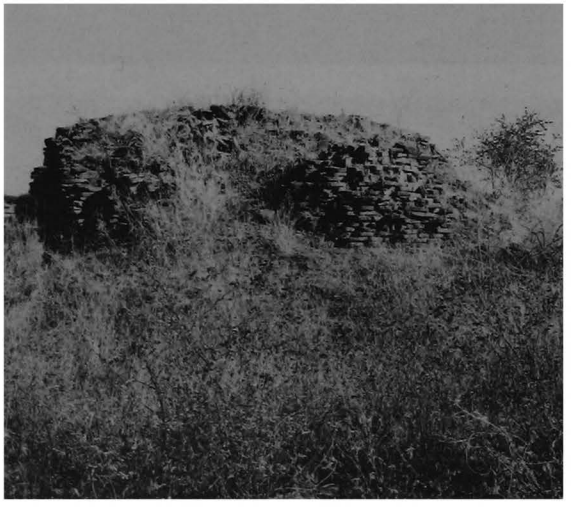
5 present condition
- ruined.
- only base of walls remains.
- ground floor buried under debris.

1009 b - From north-east

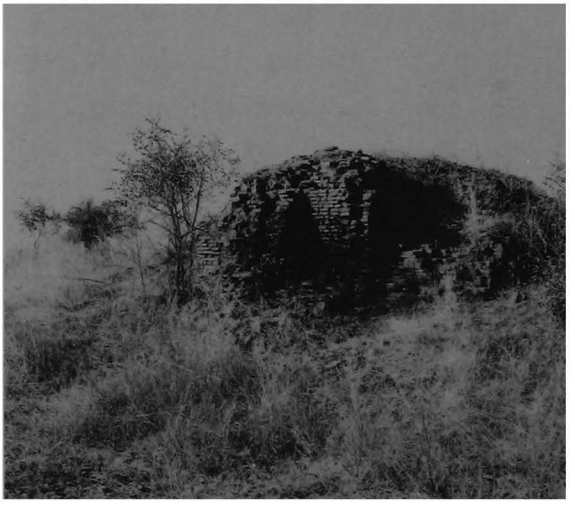
1009 c - From south

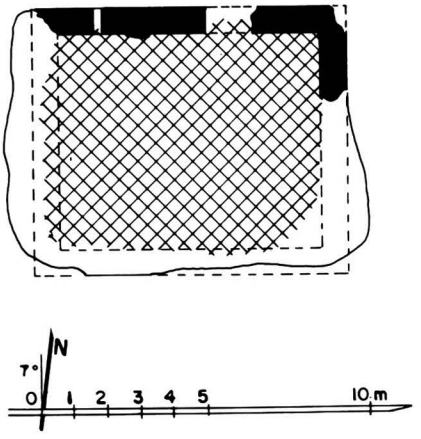
1010 a - Plan

5 present condition
- ruined.
- no more trace of vaults or roof.
- only parts of north wall remain.
- ground floor buried under debris.

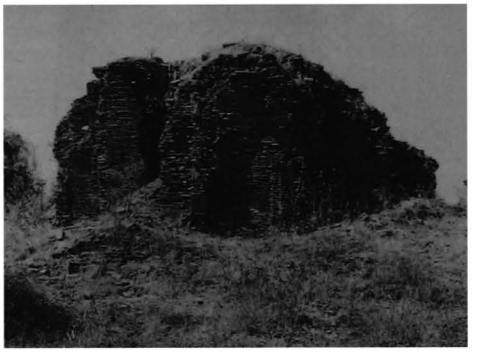
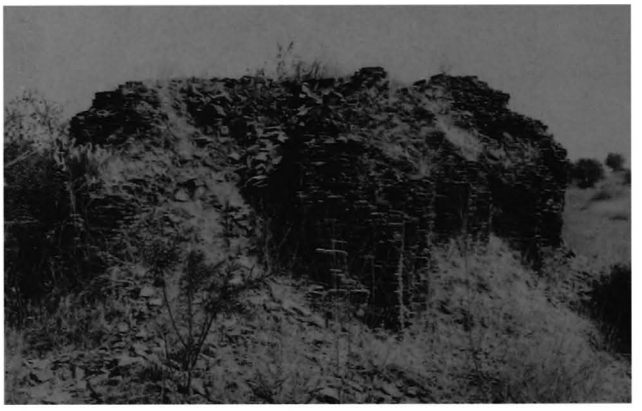
1011 b - East face

1011 c - From south-west

1011 d - West face

5 present condition
- ruined.
- base disintegrated.
- vaults and upper parts collapsed.
- ground floor buried under debris.

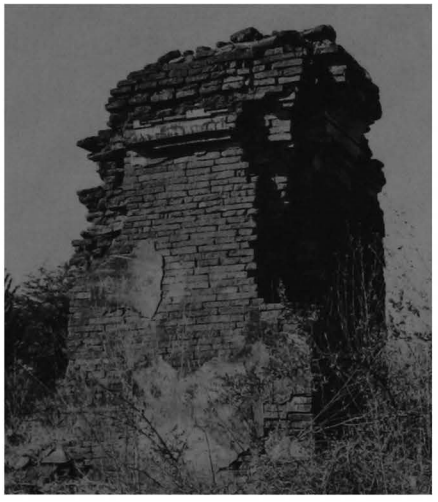
5 present condition
- ruined.
- no more trace of vaults or roof.
- only north part remains.
- ground floor buried under debris.

1012 b - North-east corner, from north-east

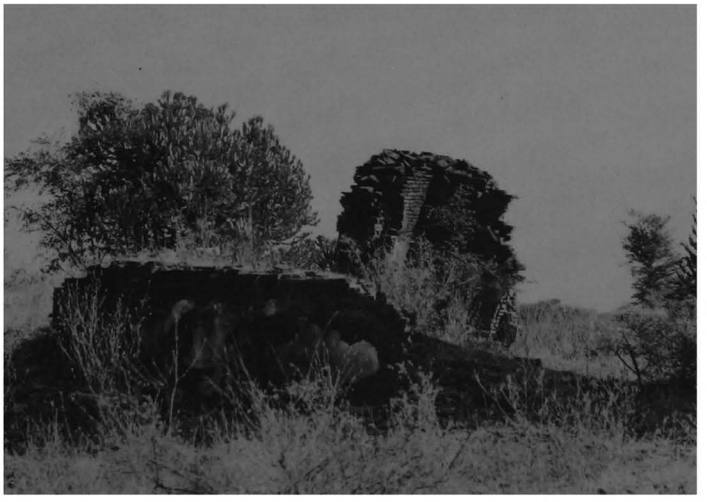
1012 c - From south-west

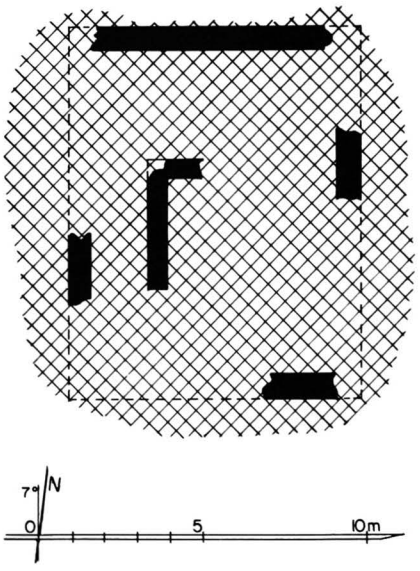
1013 a - Plan

5 present condition
- ruined.
- no more trace of vaults or roof.
- only north part remains.
- ground floor buried under debris.

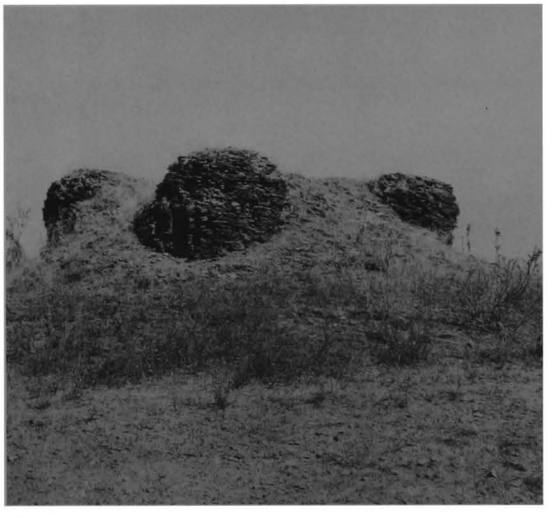
5 present condition
- ruined.
- vaults and upper parts collapsed.
- base and ground floor buried under debris.

1014 c - From south-west

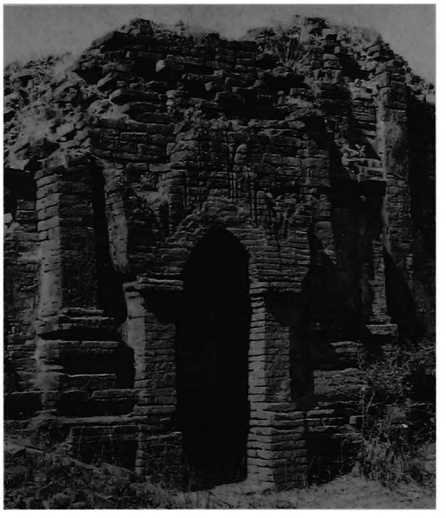
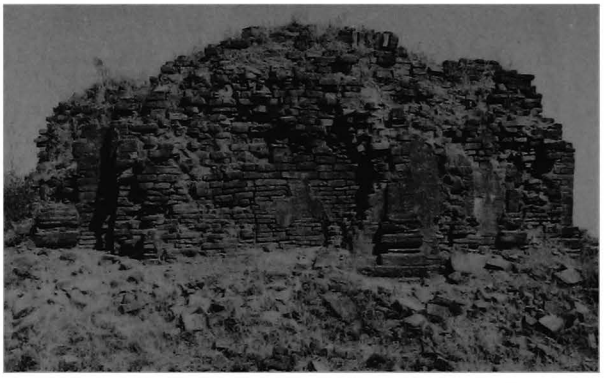
1015 b - East niche, from south-east

1015 c - East face

1015 d - South face

5 present condition
- ruined.
- vaults and upper parts collapsed.
- ground floor buried under debris.

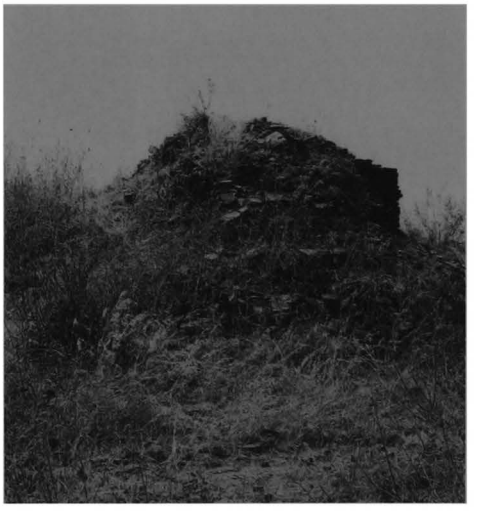
5 present condition
- ruined.
- only base of north porch remains.
- ground floor buried under debris.

1016 c - From north

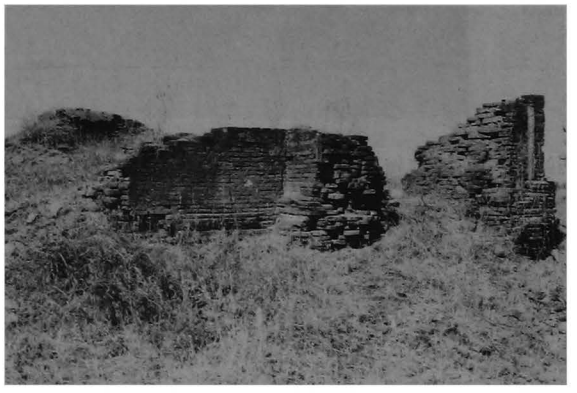
5 present condition
- ruined.
- no more trace of vaults.
- ground floor buried under debris.

1017 b - From south-east

1017 c - West room, from north-east

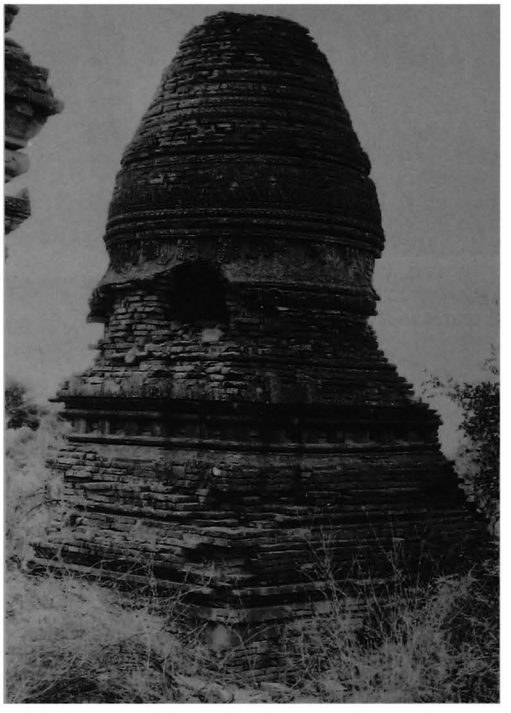
1027 d - From north-west

5 present condition
- half-ruined.
- base and terraces disintegrated.
- upper parts badly damaged.

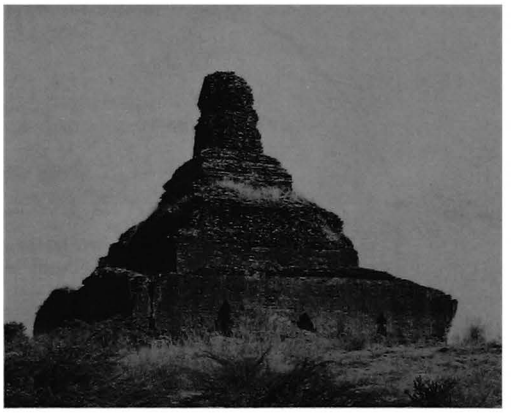
1029 b - South face, from south-west, 1986

5 present condition
- vault over corridor collapsed.
- upper parts damaged.
- ground floor buried under debris, cleared 1990.
- repaired (Arch. Dept.) 1990-92.

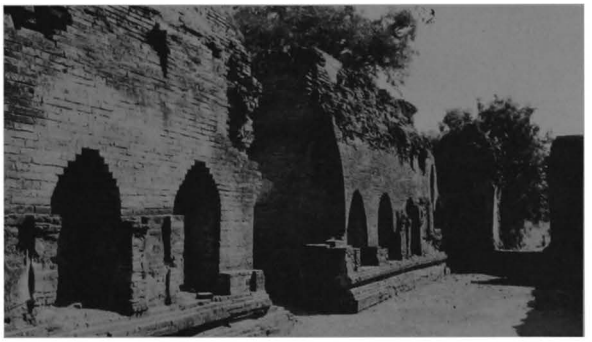
1030 e - East entrance hall, outer wall, from north

5 present condition
- vault over corridor collapsed, except over a part of east corridor.
- cleared of debris 1911-12.
- reinforced concrete slab installed 1915 over corridor.
- repaired (Const. Corp.) 1989-90.

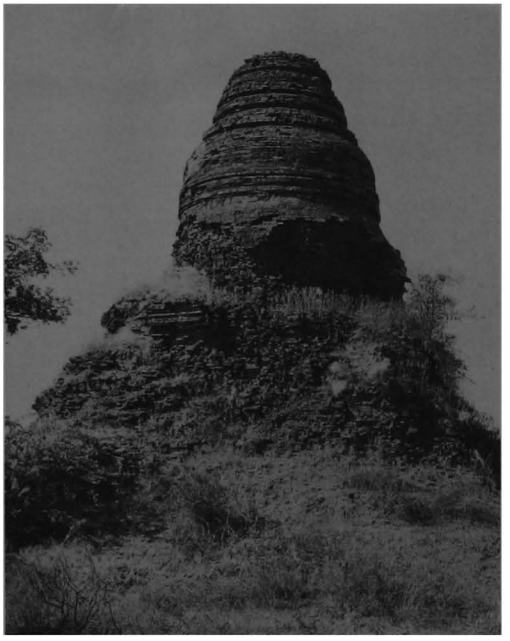
1032 b - East face

5 present condition
- half-ruined.
- base and terraces disintegrated.
- upper parts damaged.

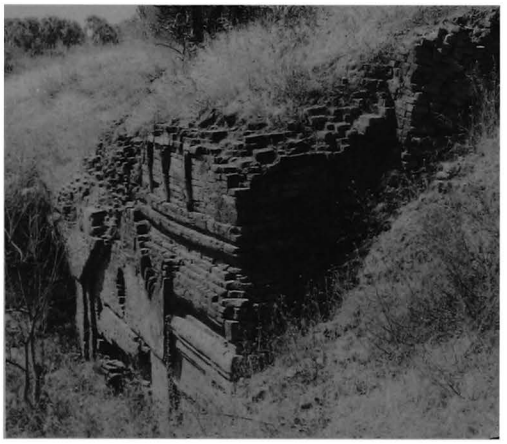
1033 b - From north-east

5 present condition
- no maintenance.
- base buried under debris, preventing access.

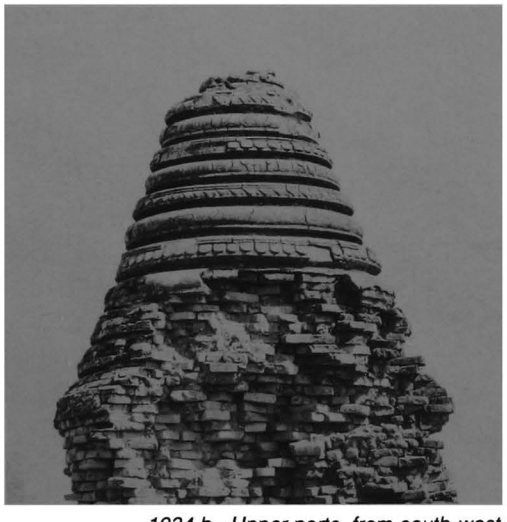
1034 b - Upper parts, from south-west

5 present condition
- half-ruined and endangered.
- base and terraces disintegrated.
- upper parts badly damaged.

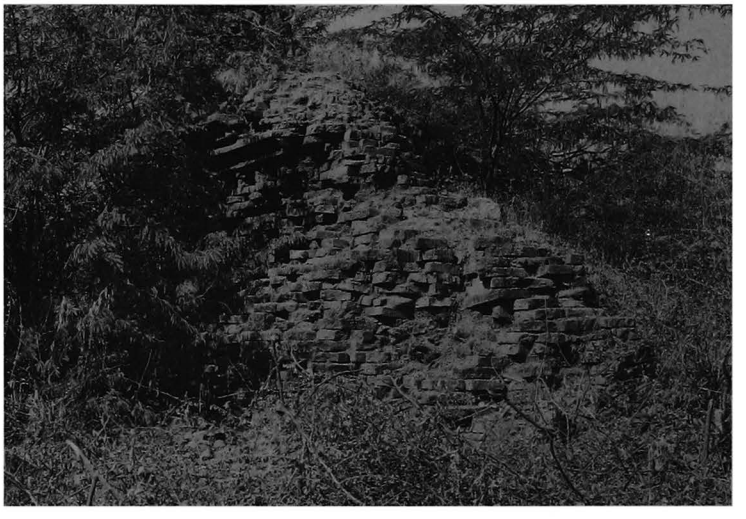
1035 b - From south-east

5 present condition
- ruined.
- only south-west corner remains.

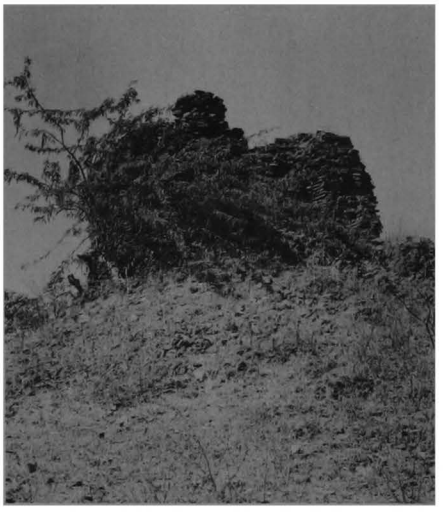
1036 b - From east

5 present condition
- ruined.
- vaults and upper parts collapsed.
- only west wall remains.
- ground floor buried under debris.

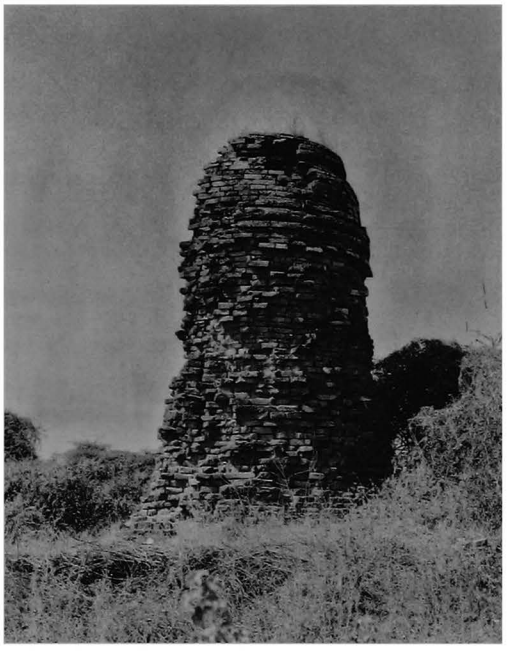
1037 b - From east

5 present condition
- half-ruined.
- base and terraces disintegrated.
- upper parts nearly destroyed.

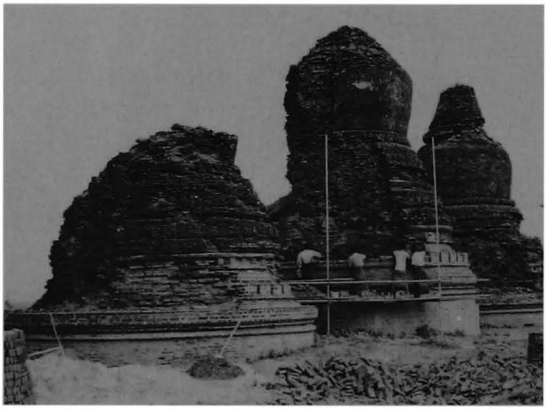
5 present condition
- upper parts nearly destroyed.
- base repaired (Arch. Dept.) 1967 and 1992.

1039 c - From south-east, 1992, together with 1040 and 1041

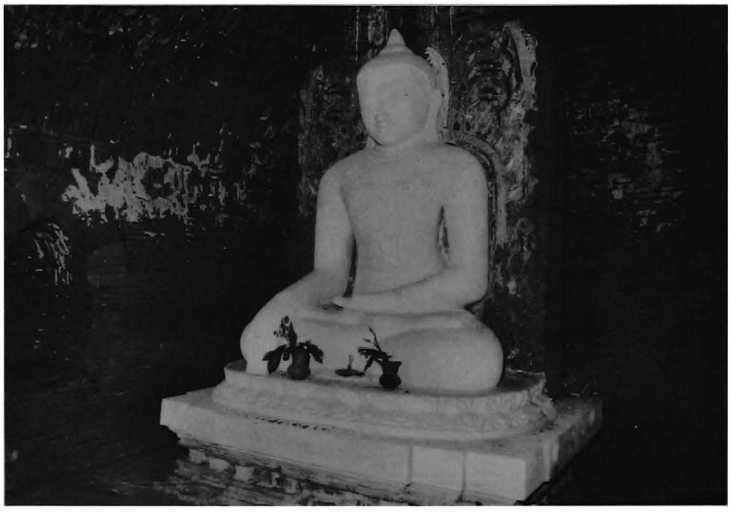
6 image
- 1 seated Buddha, facing east (renovated 1992), against a screen wall.

1042 f - Shrine, image after renovation, from north-east, 1994

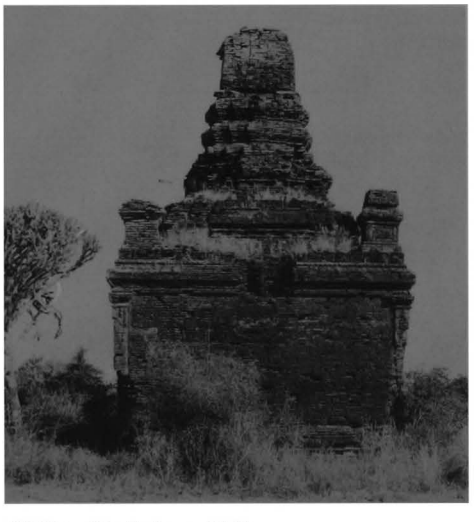
5 present condition
- porch collapsed.
- maintained.
- repaired (Arch. Dept.) 1992.

1046 c - South face, 1986

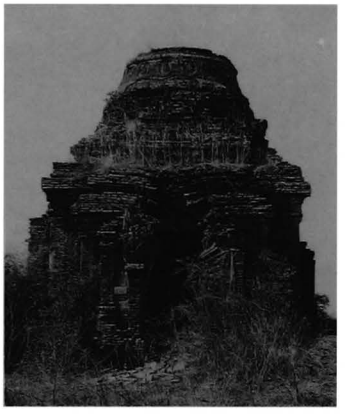
1048 d - North face

5 present condition
- no maintenance.
- base disintegrated.
- upper parts badly damaged.

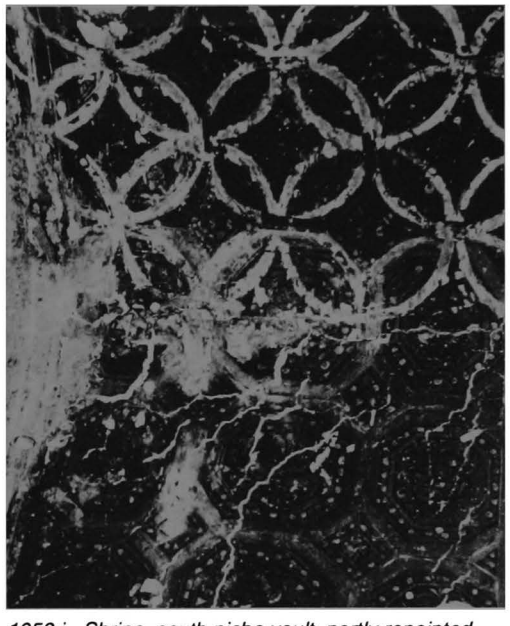
1053 i - Shrine, south niche vault, partly repainted with secant circle pattern

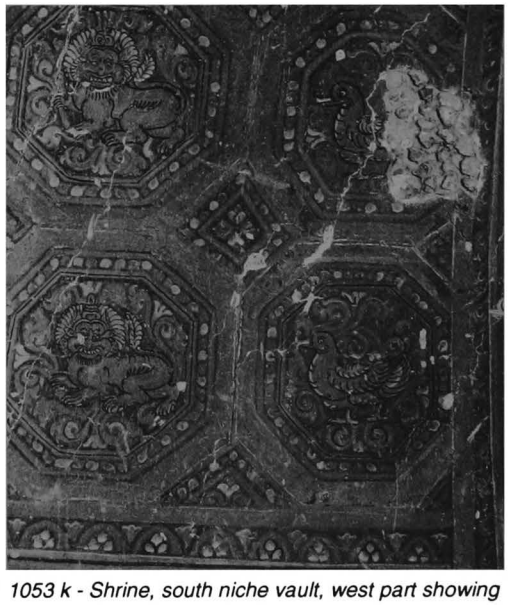
1053 k - Shrine, south niche vault, west part showing more ancient octagonal pattern

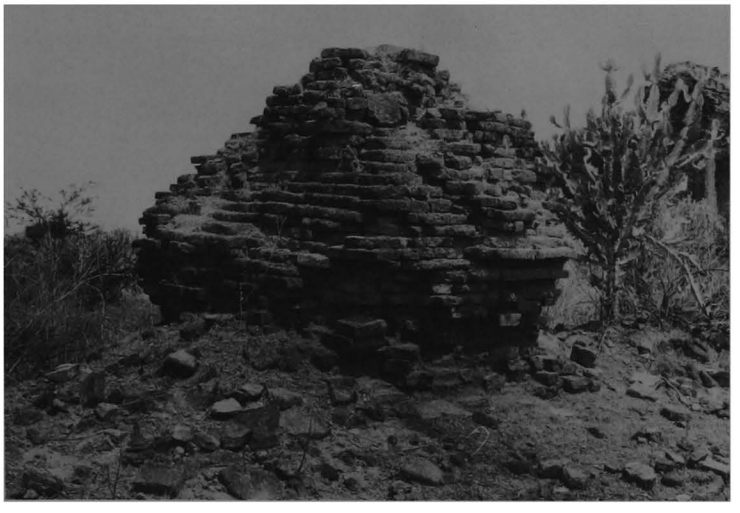
1058 b - From south-east

5 present condition
- ruined.
- height: approx. 2.30 m.

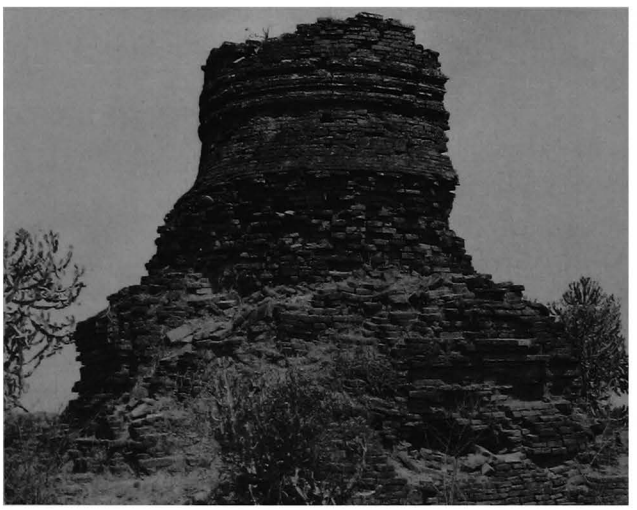
1059 c - From south-east

5 present condition
- half-ruined.
- base and terraces disintegrated.
- upper parts badly damaged.

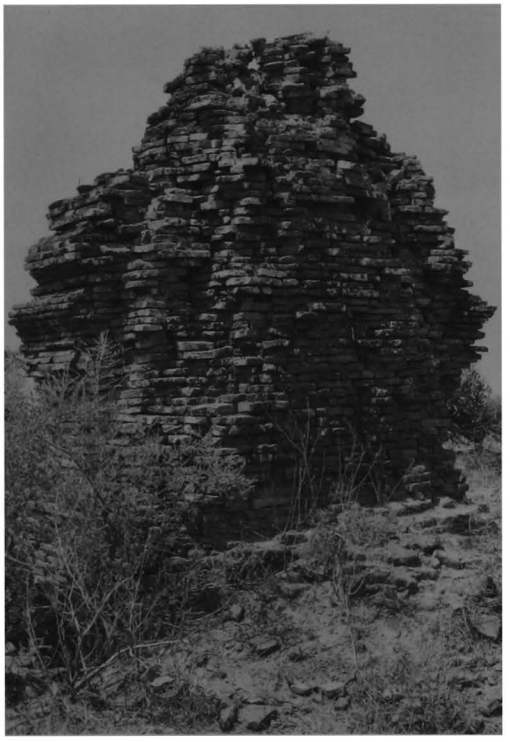
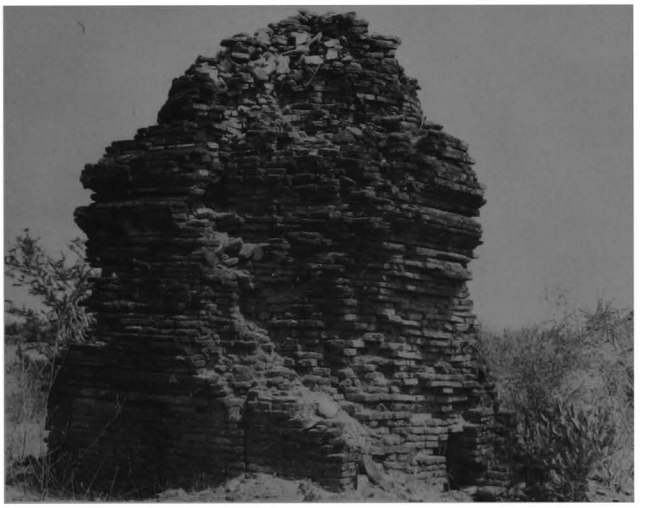
5 present condition
- half-ruined.
- base and terraces disintegrated.
- upper parts nearly destroyed.

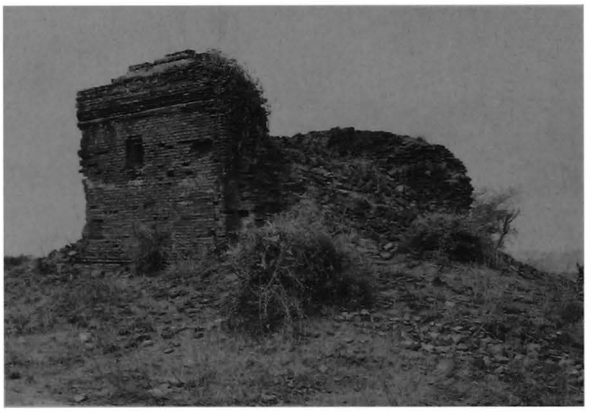
5 present condition
- ruined.
- vaults and upper parts collapsed.
- ground floor buried under debris.

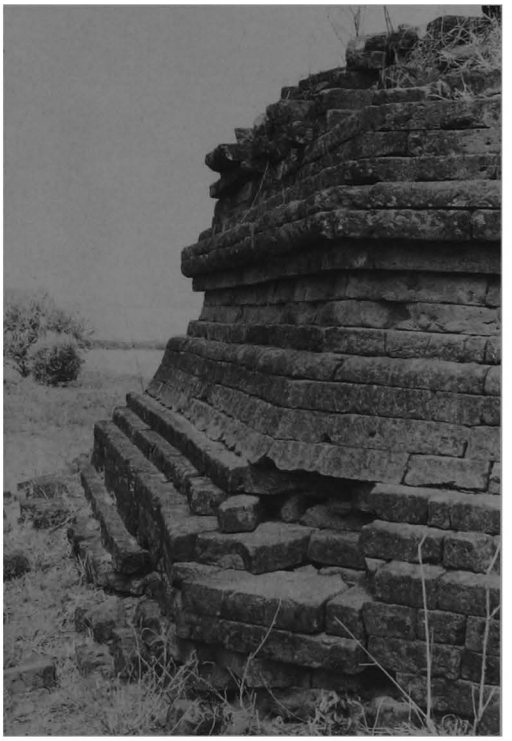
1064 d - Base, south-east side, from north-west

5 present condition
- no maintenance.
- base buried under debris.
- upper terrace badly damaged.

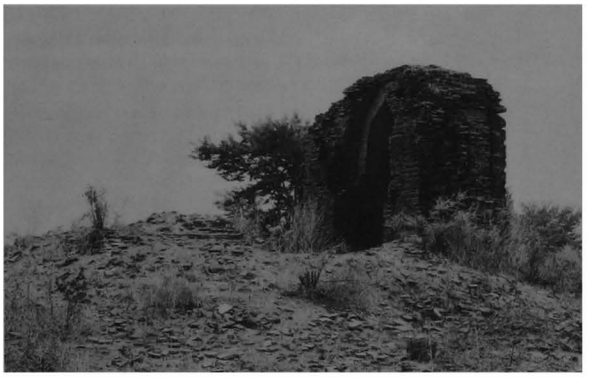
1066 c - From north-west, together with 1064 and 1065

5 present condition
- ruined.
- vaults and upper parts collapsed.
- only east porch remains.
- ground floor buried under debris.

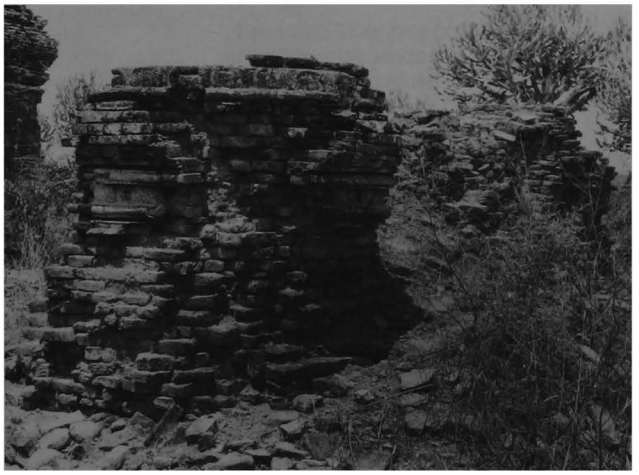
5 present condition
- ruined.
- base and terraces disintegrated.
- upper parts destroyed.

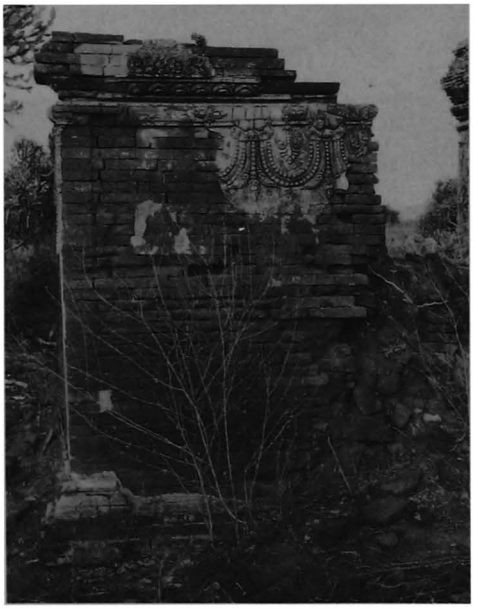
5 present condition
- ruined.
- south and east parts destroyed.
- vaults and upper parts collapsed.
- structure badly cracked.
- ground floor buried under debris.

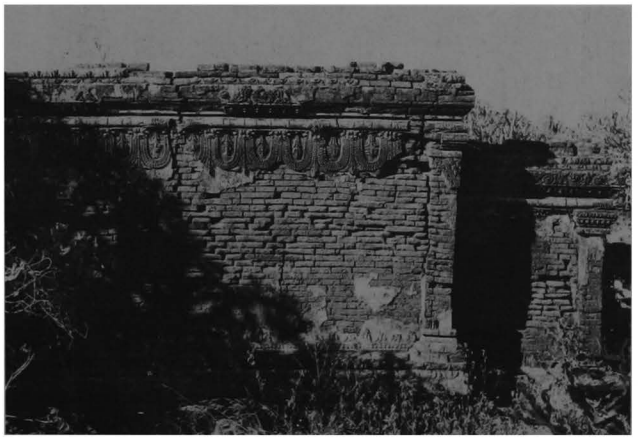
1071 c - South face

5 present condition
- ruined.
- north wall, vaults and upper parts collapsed.
- ground floor buried under debris.

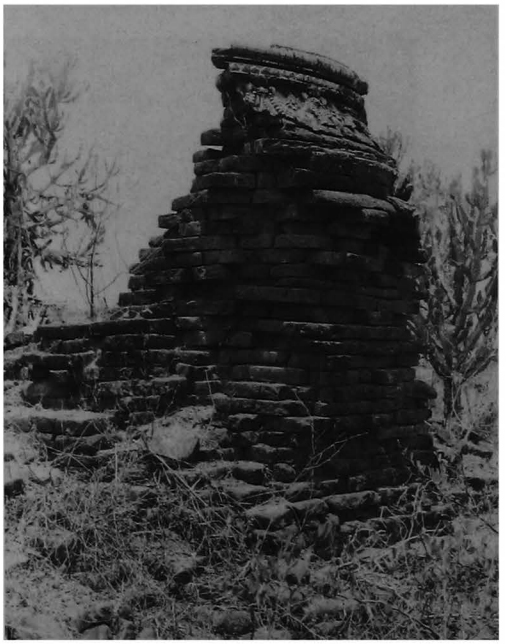
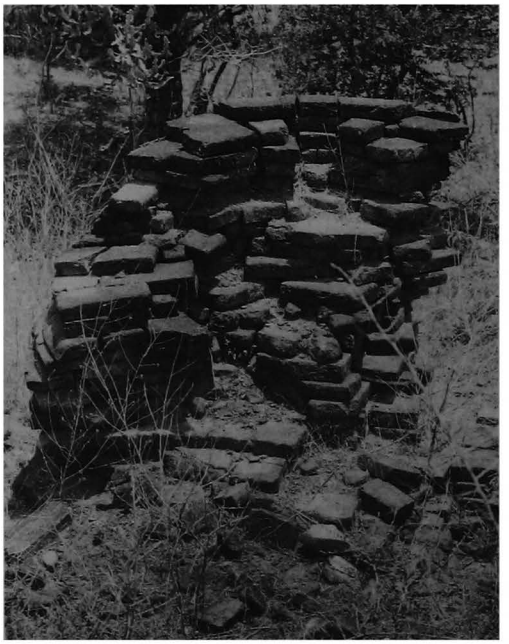
5 present condition
- ruined.
- base and terraces disintegrated.
- upper parts nearly destroyed.

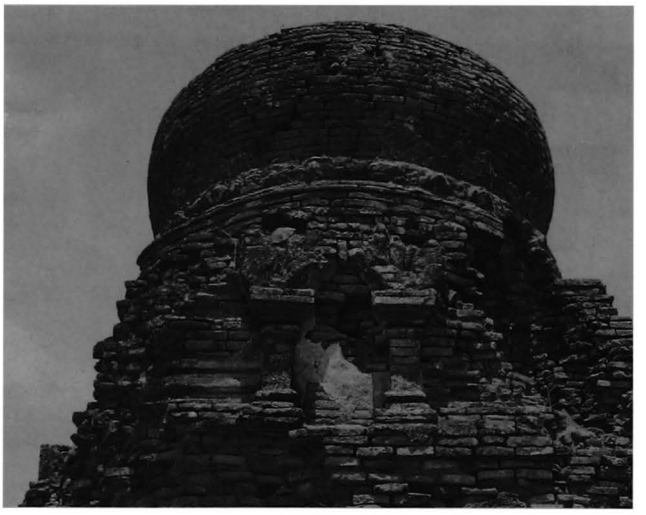
1075 b - Upper parts, east face, 1986

5 present condition
- no maintenance.
- facing of walls destroyed.
- terraces disintegrated.
- east porch collapsed.

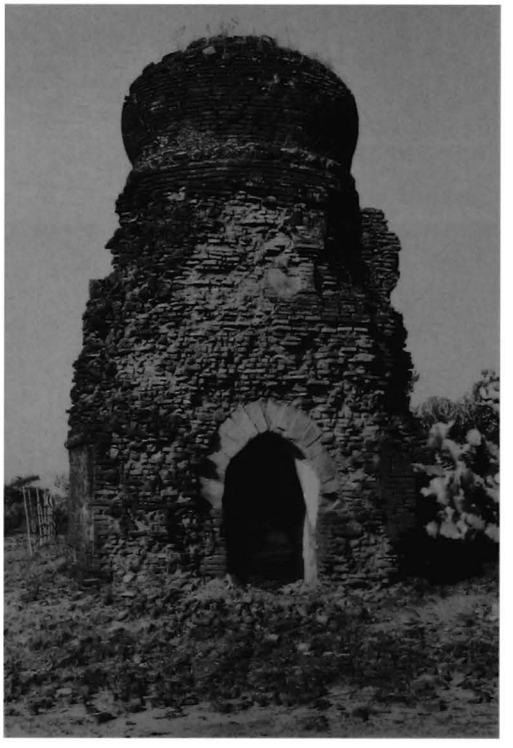
1075 c - East face, 1992, south part of axial niche destroyed

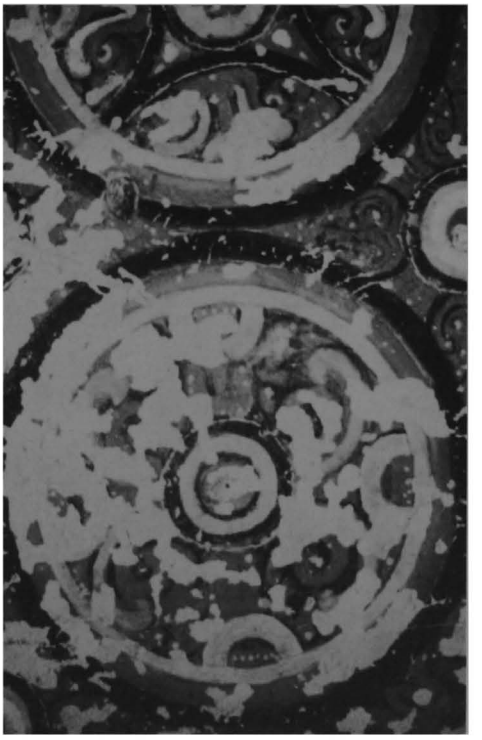
- the paintings still show their preliminary tracing: horizontal guides on the walls and a vertical axis for each figure; under the vault, each of the tangent circles has a small hole at its centre, which clearly indicates the use of a peg or needle to attach a thread, if not of a compass.

1075 g - Shrine vault, detail of tangent circles

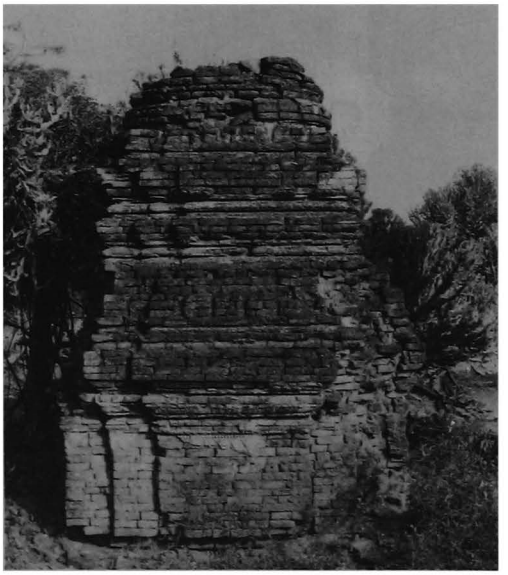
5 present condition
- no maintenance.
- upper parts nearly destroyed.
- structure leaning northwards.

1076 c - West face

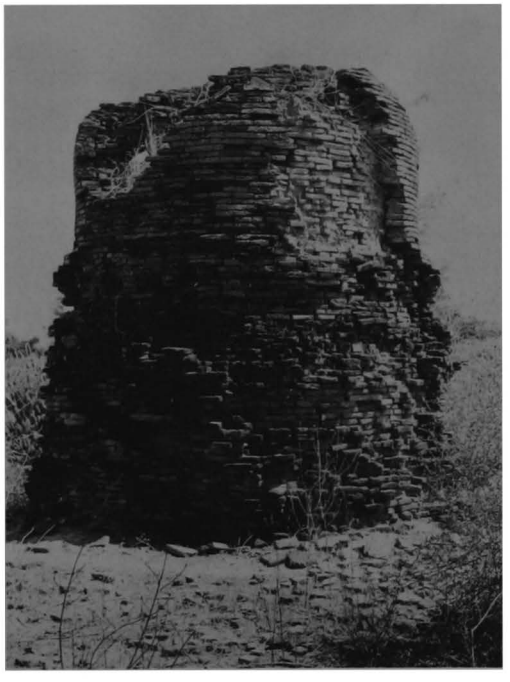
5 present condition
- half-ruined.
- base and terraces disintegrated.
- upper parts damaged.

1079 b - From south-east

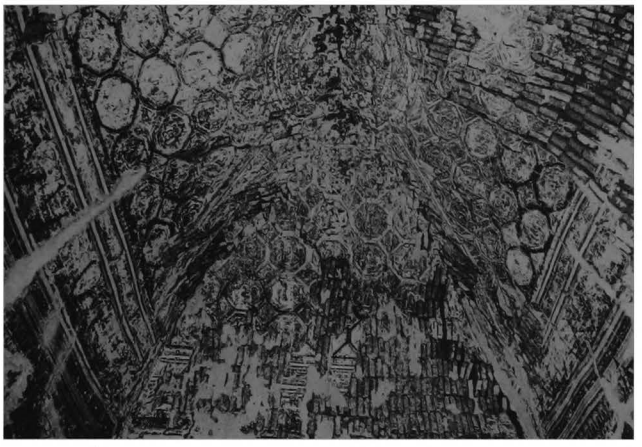
5 present condition
- regularly maintained.
- repaired 1964-65.
- vault damaged by the 1975 earthquake.

1081 h - Shrine vault, from east

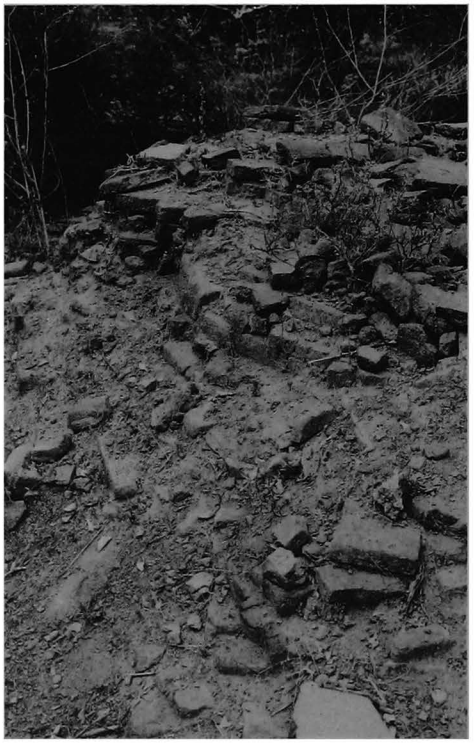
5 present condition
- ruined.
- only base remains, height: 0.80 m.

1084 b - East side, detail from north
